WELL INSPECTION REPORT

Water Source Information

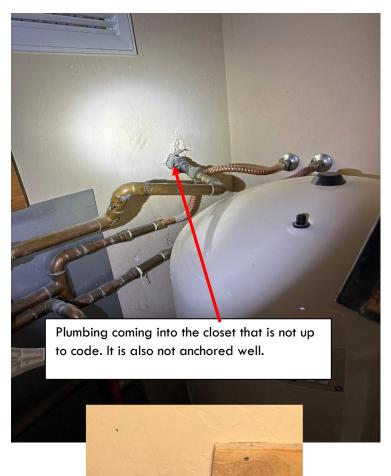
Plumbing to softener

We would recommend contacting a home plumber to look at the condition of the plumbing coming into the closet area and see if they recommend replacing that plumbing up to plumbing code.
